IMPROVED WINDSHIELD AND CANOPY PROTECTION
DEVELOPMENT PROGRAM

H. EDWARD LITTELL, JR.
PPG INDUSTRIES, INC.
PITTSBURGH, PA. 15238

TECHNICAL REPORT
AFFDL-TR-74-75

JUNE 1974

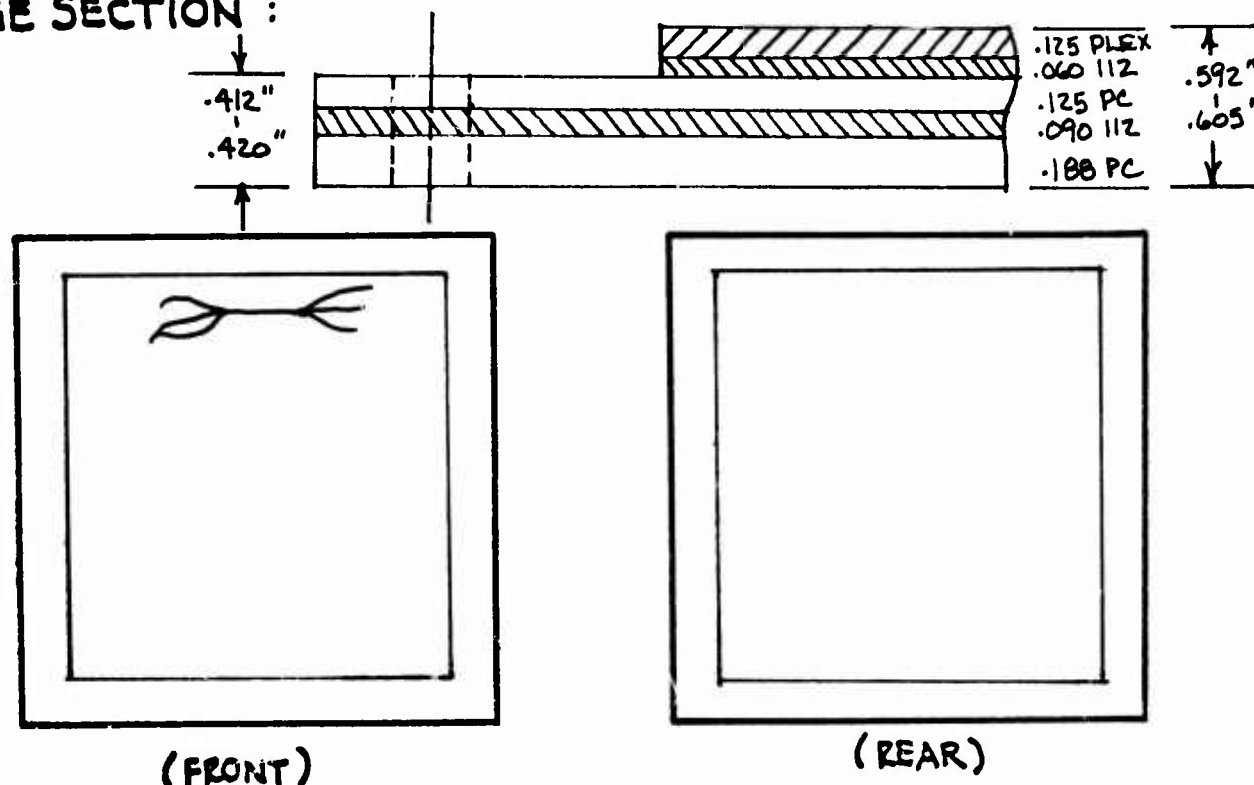
BIRD DID NOT PENETRATE. ESSENTIALLY NO STRUCTURAL DAMAGE TO PANEL. NO DAMAGE TO IMPACT SURFACE OR INBOARD PC PLY. SECOND PLY OF LAMINATE DAMAGED AS INDICATED. EXCELLENT RESIDUAL VISIBILITY. NO BOLTS BLOWN OUT BY IMPACT.

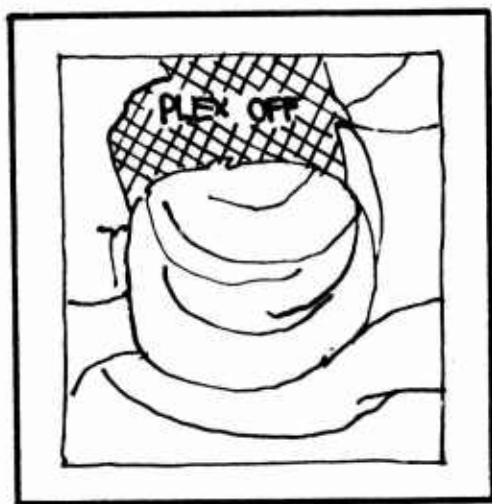
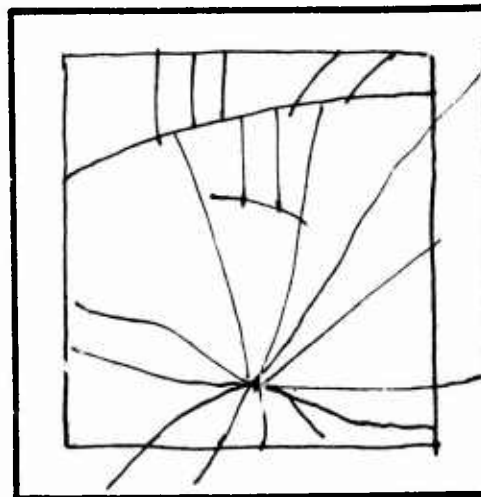
BIRD DID NOT PENETRATE. NO BOLTS REMOVED. INBOARD ACRYLIC
CRACKED SEVERELY BUT NO SPALL.

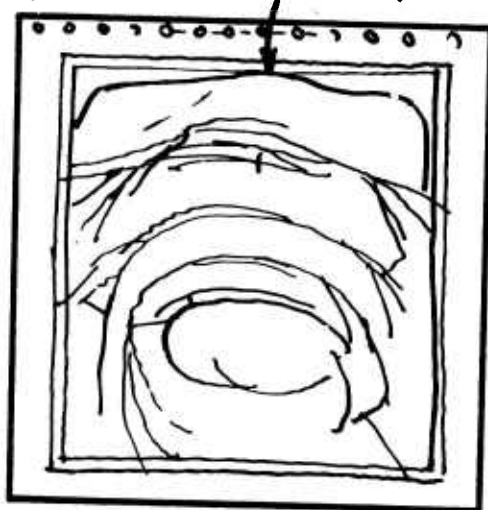
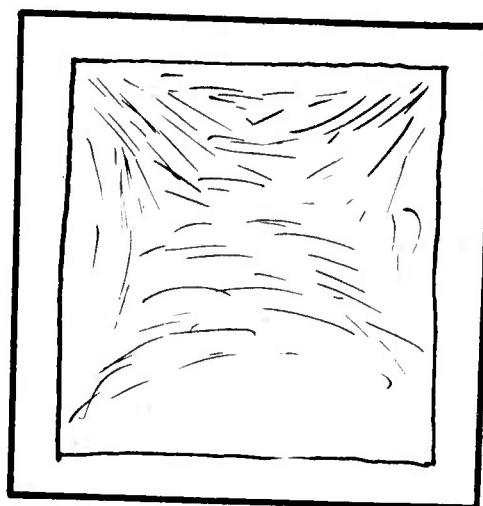
CRACK IN O/B 1/8" PC

BIRD DID NOT PENETRATE. OUTBOARD FUSED PLY CRACKED AS A SINGLE PLY IN MOST PLACES. MINOR NOMEX CRACKING AT TOP EDGE CENTER. CRACK (AS SHOWN) IN OUTBOARD .125" PC PLY STARTING AT STRAP EDGE IN CENTER.

OI 650 COATING CRAZED DURING IMPACT AS A USUAL, BUT THERE WAS NO ATTENDANT DAMAGE TO THE INBOARD .125" PC PLY.

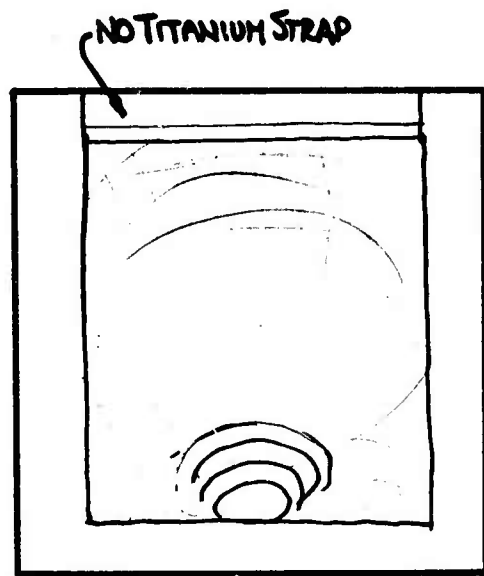
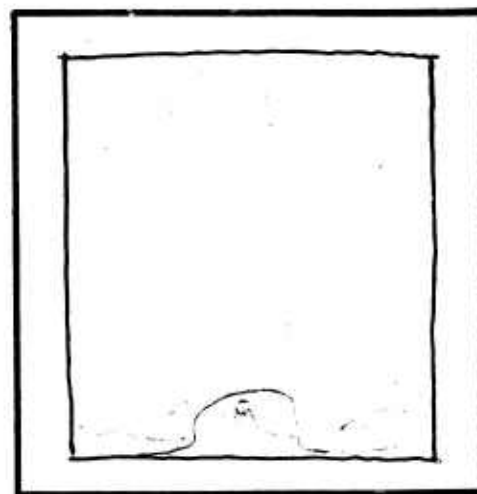
BIRD DID NOT PENETRATE, NO STRUCTURAL DAMAGE TO EDGES ATTACHMENTS. PANEL HAS ~ 1/2" RESIDUAL BULGE TOWARD 1/3 AND OVERALL WARP ~ 3/4". SPALL APPEARS TO HAVE BEEN COMPARABLE TO W/S SHOTS. NO RESIDUAL VISIBILITY. IT IS IMPOSSIBLE TO DETERMINE THE CONDITION OF THE PC PLY, BUT SINCE THERE WAS NO PENETRATION, IT IS ASSUMED TO BE OK.

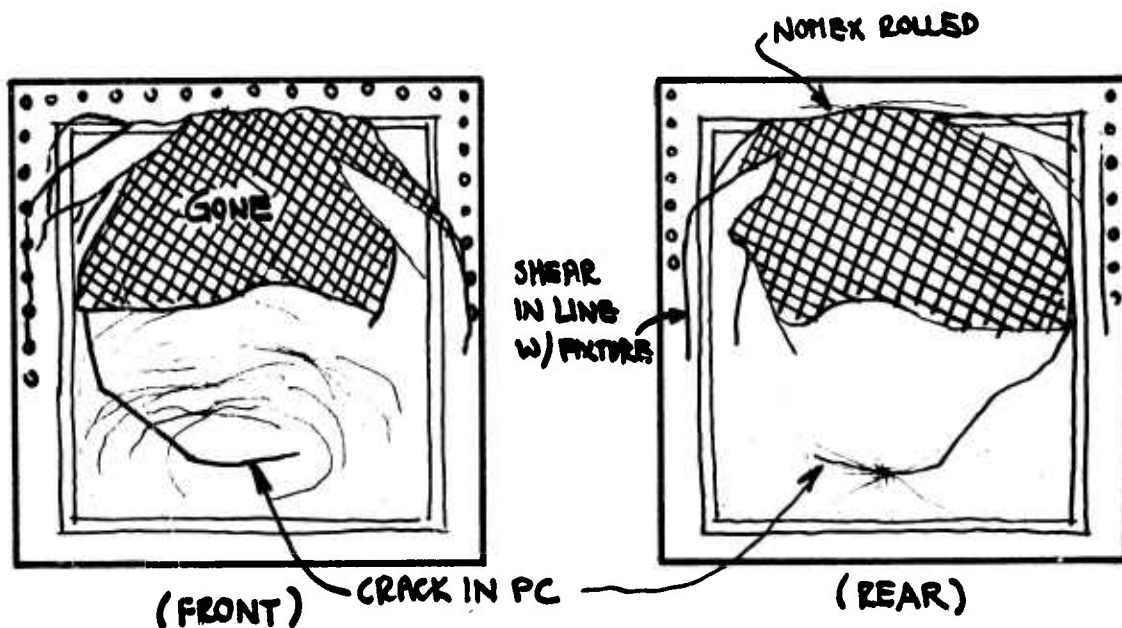
BIRD PENETRATED. BRITTLE TYPE FAILURE WITH TOP HALF OF PANEL BLOWN OUT IN ONE MAJOR PIECE. EDGE SHEARING IN LINE WITH FIXTURE. TOP EDGE SHEARED OUT IN LINE WITH .080" NOMEX STRAP. CRACK IN PC IN LINE WITH PLEX CRACK AT IMPACT POINT, BUT NOT EXACTLY COINCIDENT (I.E. CRACK DID NOT PROPAGATE THRU .090" IIZ).

GOOD ADHESION TO PLEX & CR-39. CR-39 FRACTURE PATTERN MORE COMPLETE THAN SEEN WITH ACRYLIC.

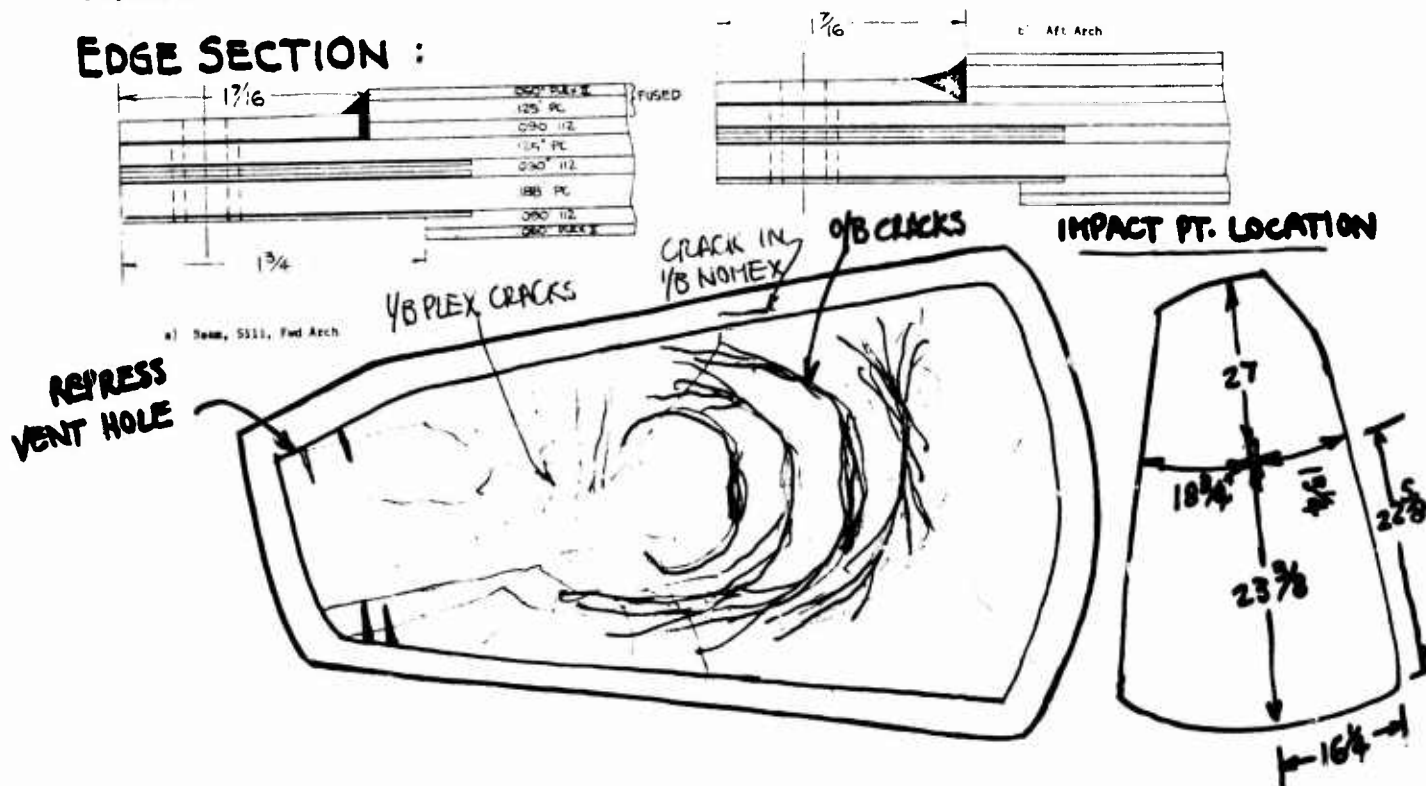
BIRD DID NOT PENETRATE. NO APPARENT DAMAGE TO PC PLIES. BOTH FACING PLIES CRACKED AS SHOWN ABOVE. NO ACRYLIC SPALL FROM INBOARD DURING DEFLECTION. CRACK IN INBOARD NOMEX AT BEAM AS SHOWN. REMOVAL OF SECTION OF STRAP SHOWS THAT CRACK IS IN REINFORCEMENT, NOT PC. SLIGHT NOMEX TENSILE WHITENING AT BOLT HOLES NEAR CRACK.

REPRESS DOES NOT APPEAR TO HAVE HAD ANY EFFECT. NO DAMAGE TO RETAINER. ALL BOLTS AND BUSHINGS OK.

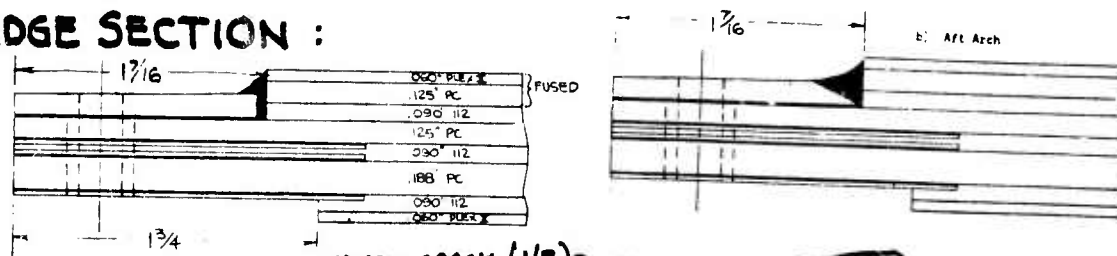
NOMEX CRACK (1/8")

BIRD DID NOT PENETRATE. RESIDUAL BULGE (3" DEEP, 7" DIAMETER) LOCATED 4" BEHIND TARGET "X". ACRYLIC SPALL OFF 5"x4" AREA AT MAXIMUM BULGE (90% OFF) NEITHER 1/8" OR 3/16" PC CRACKED, EVEN IN EXTREME BULGE.

CRACK (26" LONG) IN INBOARD BEAM EDGE REINFORCEMENT IN LINE WITH BENDING OVER FRAME. REMOVAL OF STRAP SECTION SHOWS THAT THE CRACK IS ONLY IN THE NOMEX (WITH 1 PLY STILL OK) AND NO DAMAGE TO THE PC.

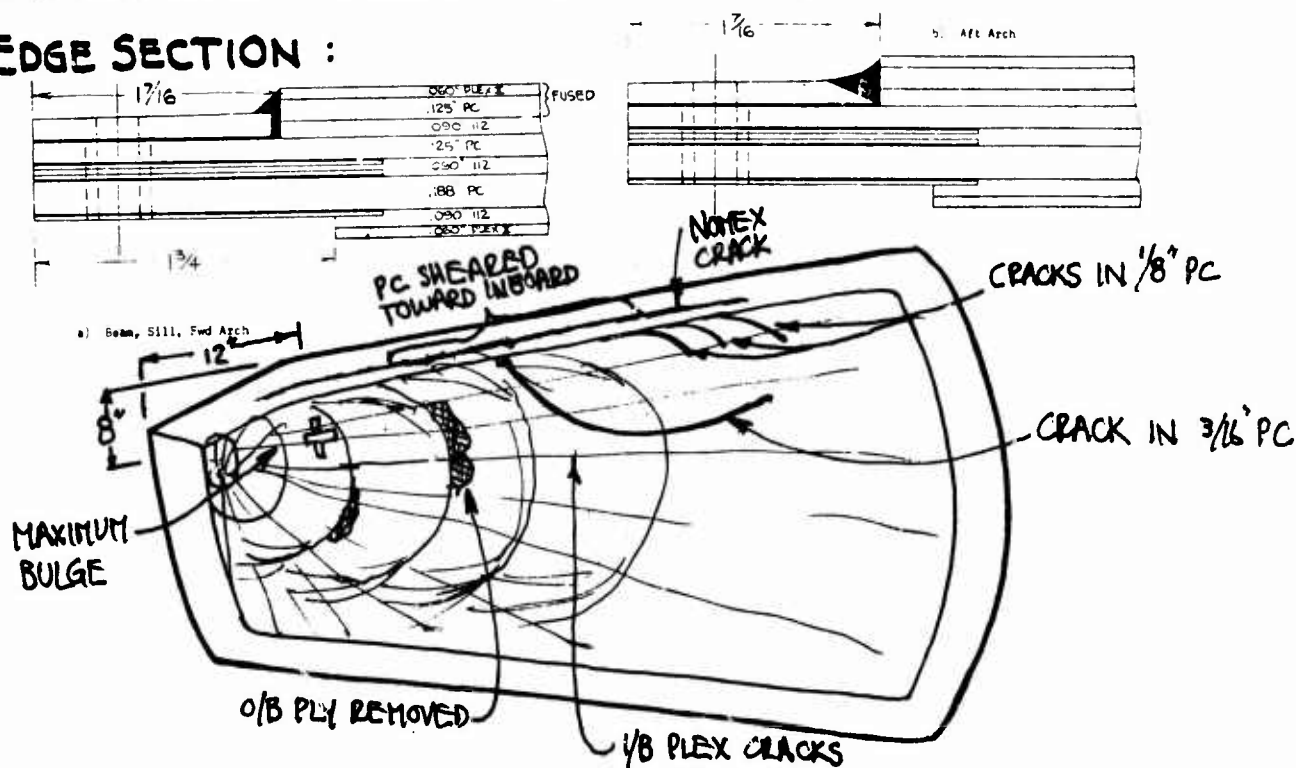
BIRD DID NOT PENETRATE. LARGE RESIDUAL BULGE WITH ACRYLIC SPALLED IN MAX. BULGE AREA. CRACK IN BEAM EDGE ATTACHMENT AND PC WITH CRACKS FROM EDGE SHEAR LINE INTO VISION AREA IN BOTH 1/8" & 3/16". OUTWARD PLY PULLED AWAY FROM RETAINER ALONG FORWARD HALF OF BEAM. APPROXIMATELY 1/4" OUTWARD PERMANENT WARP IN FWD. HALF OF BEAM EDGE. CLOSE TO LIMIT.

RETAINER OK EXCEPT LOOSE FOR 12" ALONG BEAM STARTING AT CORNER WITH FORWARD ARCH.

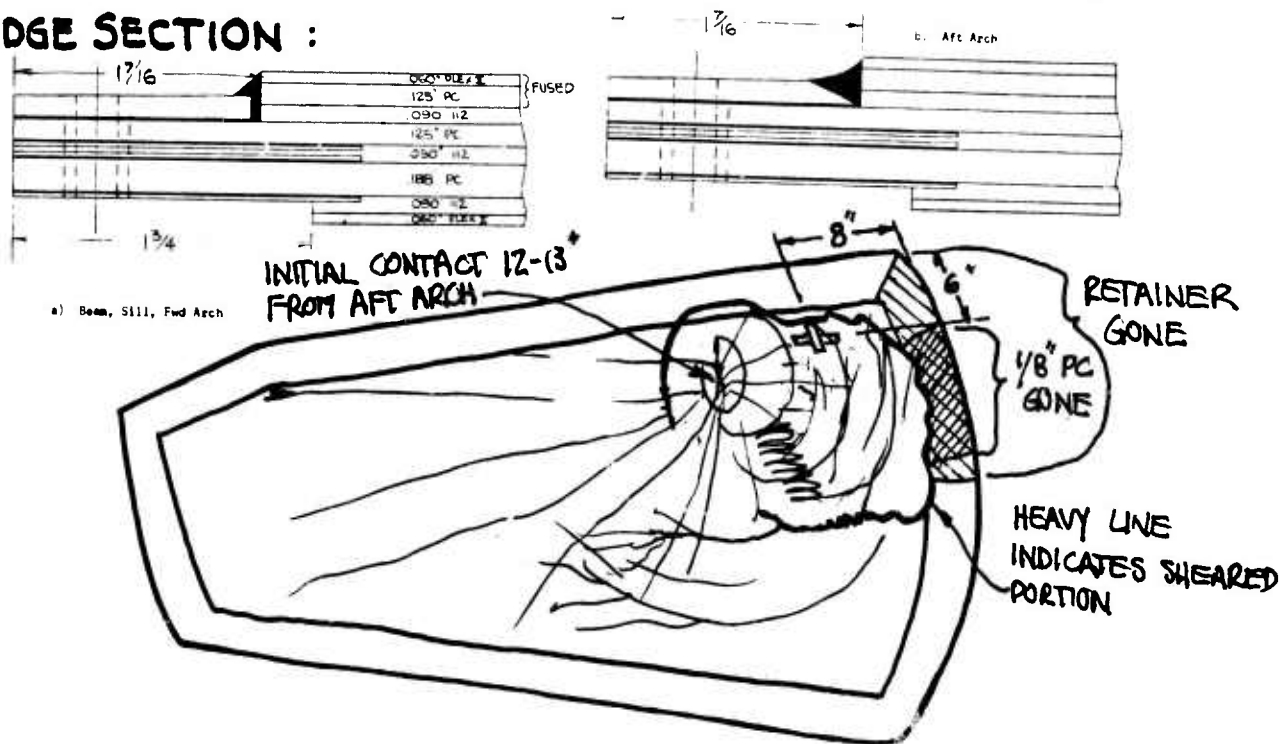
BIRD PENETRATED. CORNER OF AFT ARCH AND BEAM SHEARED AND OPENED AS SHOWN. SECTION OF RETAINER BLOWN OFF, BUT NOT PEELED, INDICATING NO TUNNELING. ELEVEN BOLTS OFF; FIVE BOLTS STILL IN RETAINER. RETAINER BOLTS BENT BUT INTACT WITH FAILURE BY PULLING OUT OF NUTS.

SHEAR LINES IN PENETRATED CORNER VARY IN LOCATION FROM PLY TO PLY. EXACT MODE OF FAILURE CANNOT BE DETERMINED. SOME PLEX SPALL FROM BULGE/FLAP. IN STRIPPED EDGE SECTION, POOREST RTV/630 ADHESION WAS TO THE PC. APT 18" OF BEAM EDGE WARPED OUTWARD ~ 3/8".

LITTLE DAMAGE TO REMAINING 3/4 OF PANEL.

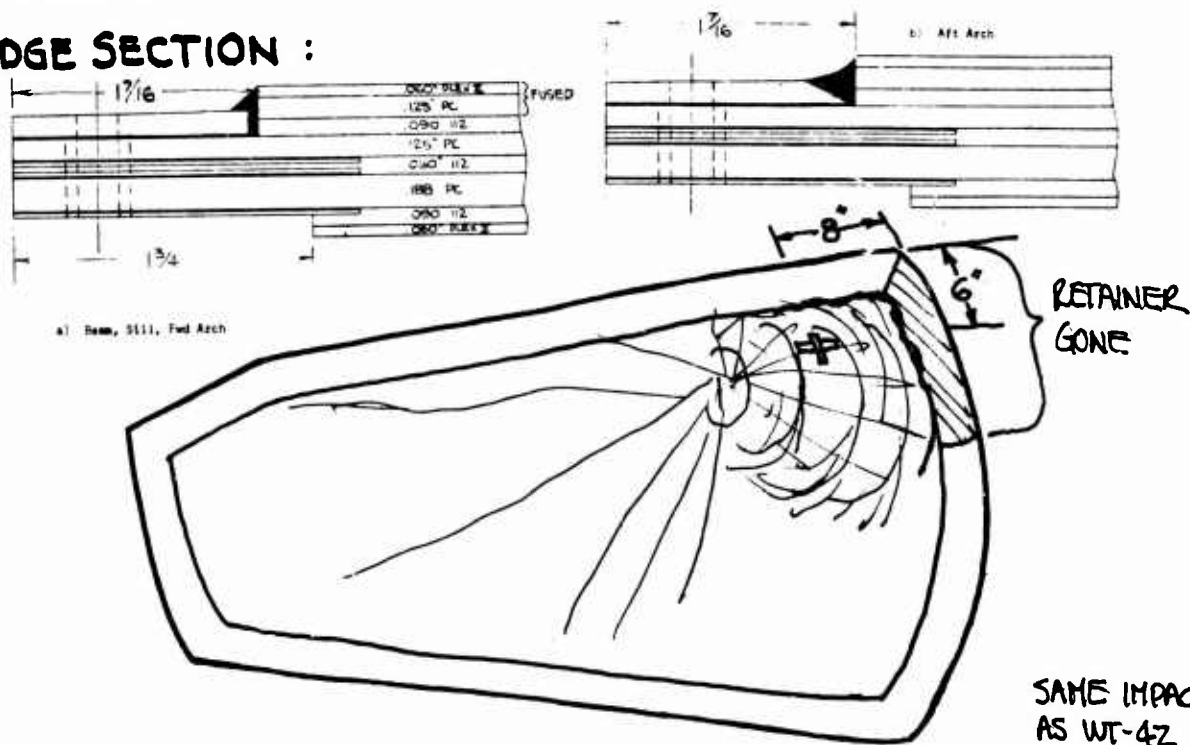
BIRD PENETRATED. FAILURE SIMILAR TO 9030-23 (WT-42) ALTHOUGH LESS SEVERE. SECTION OF THE AFT ARCH RETAINER REMOVED AND BOLTS PULLED OUT OF THE NUTS. IMPACT SLIGHTLY CLOSER TO THE BEAM THAN 9030-23. AFT PORTION OF BEAM EDGE DEFLECTED O/B ~ 3/8".

SHEAR FLAP AND DAMAGE TO REMAINDER OF WINDSHIELD LESS THAN 9030-23. CLOSE TO LIMIT. WOULD PROBABLY PASS WITH LESS RIGID FRAME.

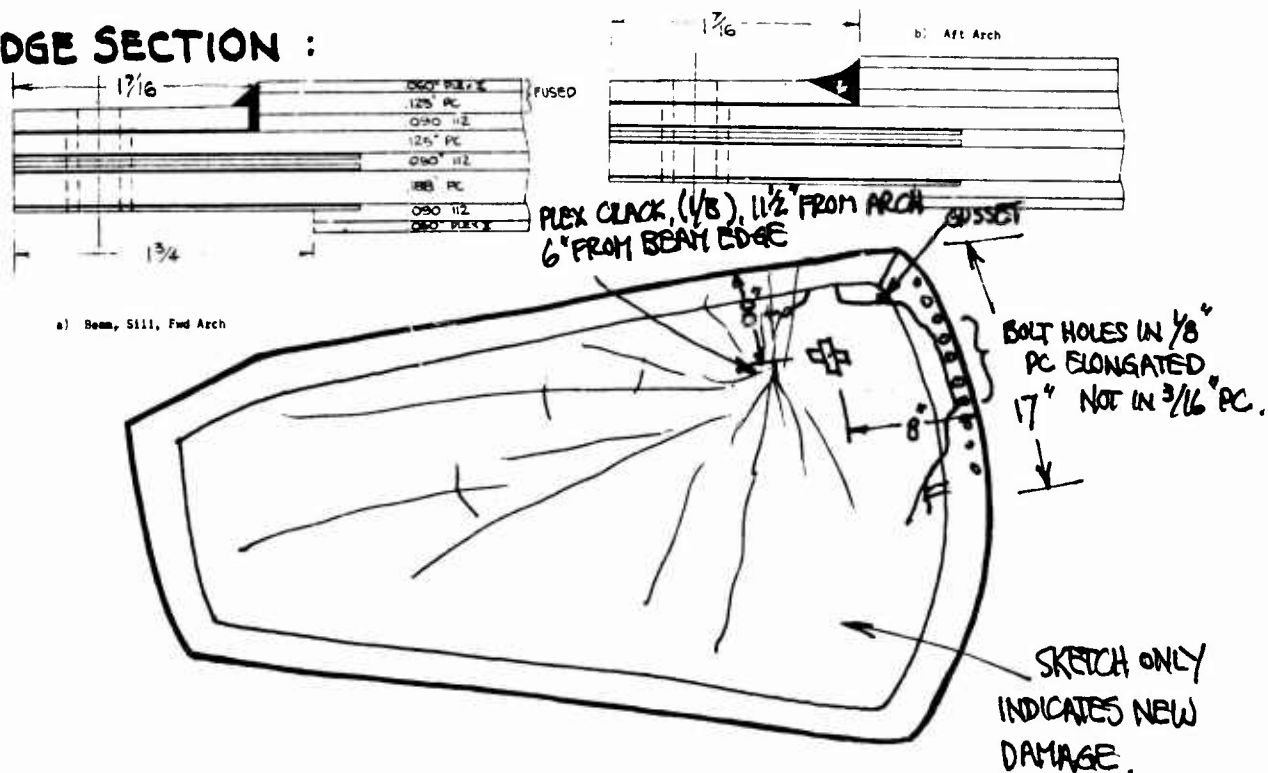
FAILURE DUE TO SHEARING OF 3/16" PC PLY IN LINE WITH EDGE OF SUPPORT AND SUBSEQUENT TENSILE FAILURE OF 1/8" PLY OF PC. SHEARING IS REMINISCENT OF EARLY FLAT PANEL FAILURES PRIOR TO FRAME GRINDING. BOLT HOLE DEFORMATION (OR LACK OF IT) SHOWS THAT 3/16" PC IS DOING NO WORK BEFORE SHEARING.

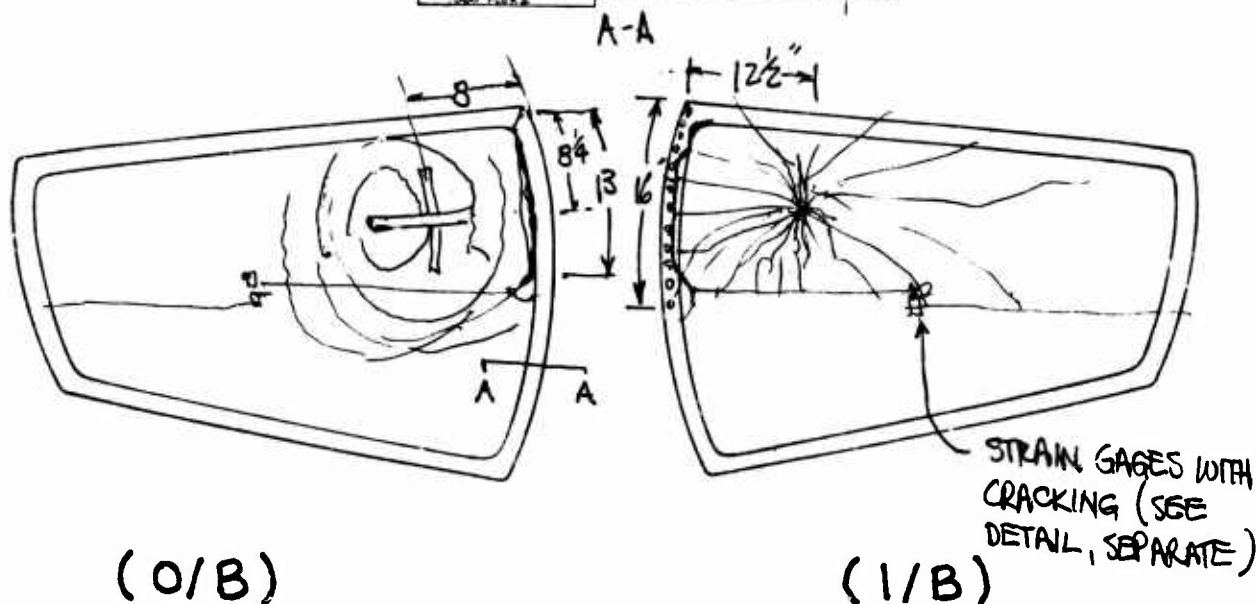
CORNER, AFT OF IMPACT POINT "SHEARED", PERMITTING TISSUE TO PENETRATE. BOTH PC PLIES FAILED ALONG 13" LINE COINCIDENT WITH END OF SUPPORT LEDGE. HOWEVER, PC DID NOT SHEAR. NO CRACK AS RESULT OF T_i STRIP WHICH ROTATED AND YIELDED ALONG ARCH. PC PUSHED PAST T_i STRIP. NEGLIGIBLE RESIDUAL ROTATION OR DEFLECTION OF ARCH WITH MCAIR'S INTERIM MODIFICATION.

FAILURE LESS SEVERE THAN WT-44, BUT TISSUE PENETRATION COMPARABLE. ^{CRACKING} CRACKS FROM TAPE HOLDING STRAIN GAGE WIRES DID NOT AFFECT RESULTS.

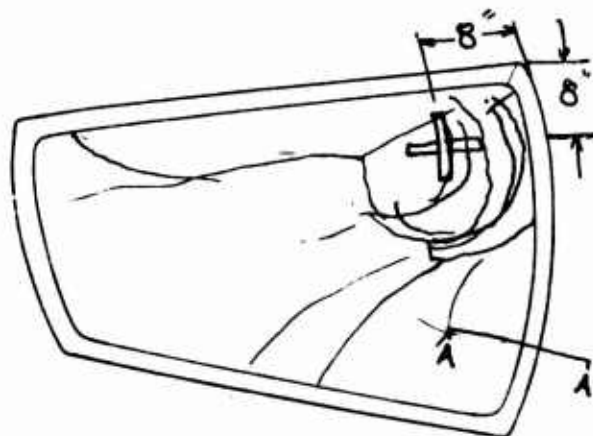
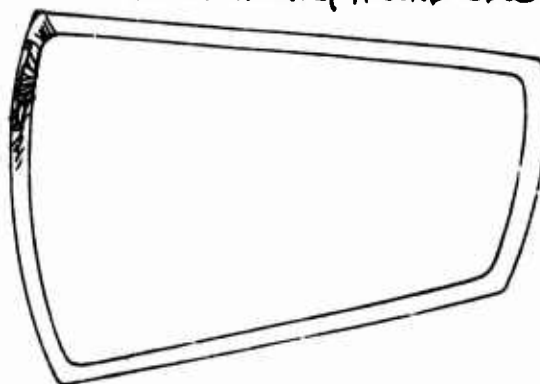
BIRD DID NOT PENETRATE, OUTBOARD PLY CRACKED BUT NO OBSERVABLE FRACTURING OF STRUCTURAL PC PLIES. TITANIUM STRIP BENT OVER LEDGE DURING DEFLECTION BUT NO SHEARING. NOMEX CRACKED UNDER STRIP, IN LINE WITH END OF LEDGE. DEFORMATION OF PC UNDER NOMEX CRACK BUT NO FRACTURE. NUMEROUS "STRESS CRACK" CRACKS IN INBOARD NOMEX IN AREA OF MAX. DEFLECTION.

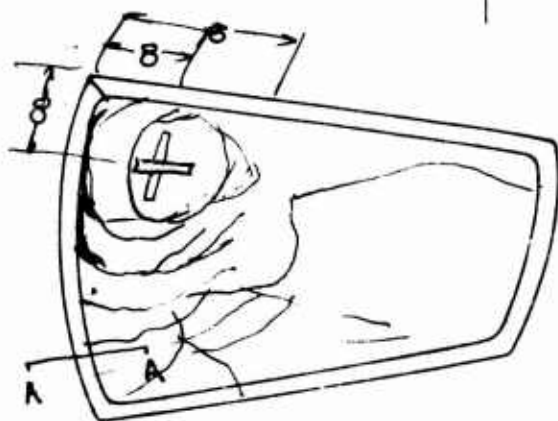
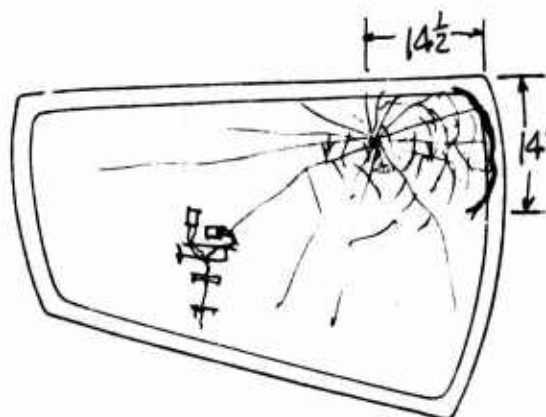
ARCH CORNER, AFT OF IMPACT POINT, "SHEARED" AND PERMITTED TISSUE TO PENETRATE. PC PILES FAILED GENERALLY COINCIDENT WITH ARCH SUPPORT LEDGE END, ALTHOUGH FAILURE OF THE I/B WAS NOT A CLEAN SHEAR AS WITH WT-44. FAILURE WAS PRACTICALLY IDENTICAL TO WT-47 (9030-31) WITH ESSENTIALLY THE SAME PC FAILURE PATTERN IN BOTH. THE PC PUSHED PAST THE STAINLESS STEEL STRIP WHICH WAS YIELDED IN BENDING OVER THE ARCH PLUS ELONGATED LONGITUDINALLY, BUT NOT SHEARED. THE FWD. EDGE OF AFT RETAINER WAS PUSHED DOWN IN THIS SHOT THERE WAS GREATER RESIDUAL ROTATION OF THE ARCH WITH THE MCAIR INTERIM FIX.

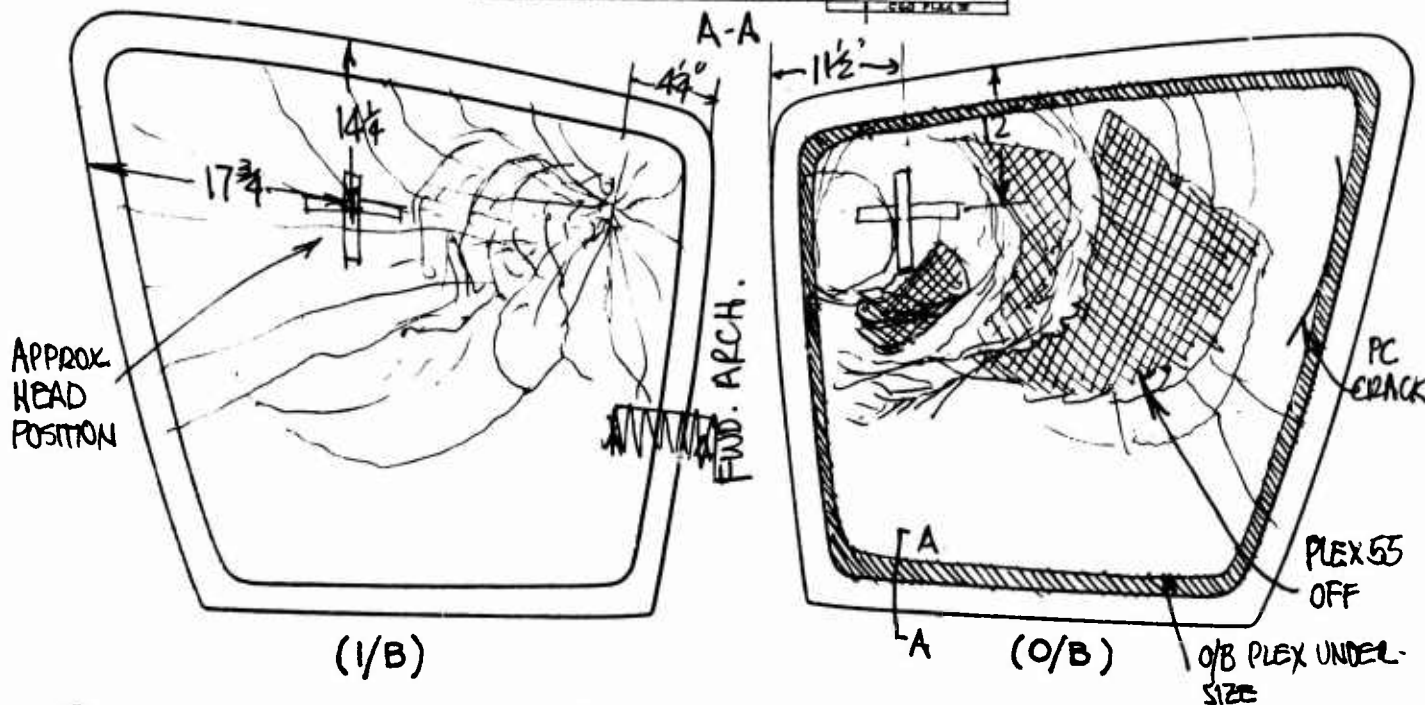
REMARKS : CSK. BOLT FWD ARCH ; PRG HATCH.*
BIRD DID NOT PENETRATE. NO VISIBLE PC DAMAGE. OUTBOARD PLY OF
PLEX 55 CRACKED WITH MUCH MORE REMOVED THAN EXPERIENCED WITH PLEX II.
NO PLEX II SPALL FROM I/B SURFACE & NO CRACKS INTO .030" IIZ.

* NOT TRUE. CRACK IN OUTBOARD PC PLY VISIBLE AT REAR ARCH AS
SHOW IN SKETCH ABOVE.

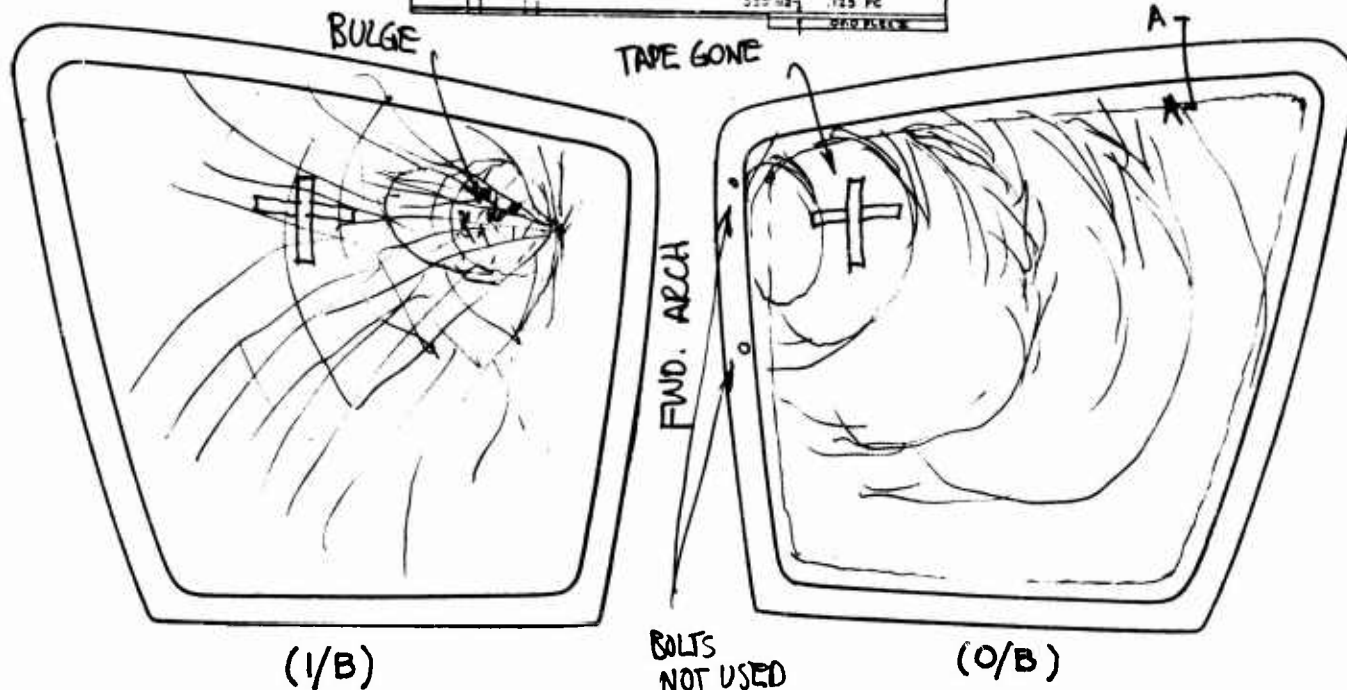
BIRD DID NOT PENETRATE, SAME IMPACT PT AT WT-52. AEDC HATCH.
LARGE RESIDUAL BULGE CENTERED $\sim 4"$ BEHIND IMPACT TARGET. SOME PLEX
BLOWN OFF IN BULGED AREA LIKE HIGH SPEED WINDSHIELD SHOTS. LOTS OF
DAMAGE TO FACING PLEX RESULTS IN POOR RESIDUAL VISIBILITY. NO CRACKS
INTO .030" IIZ.

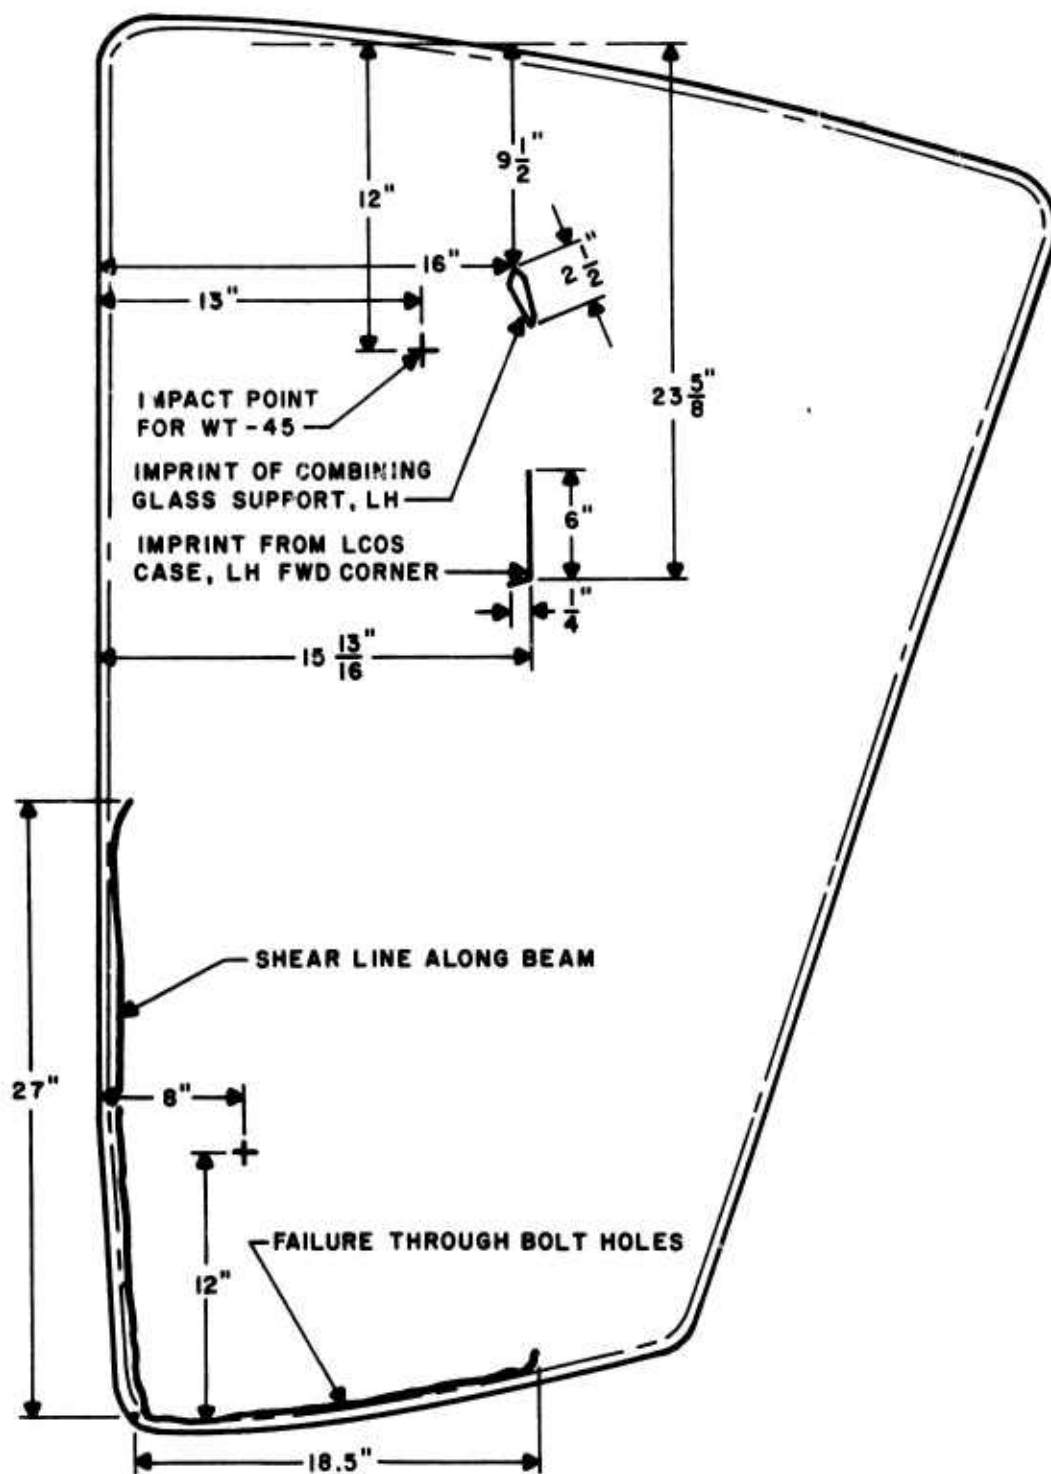
FIGURE 53. IMPACT RESULTS FOR WT 45 & 46.

<u>Test No.</u>	<u>Mounting Conditions</u>	<u>Impact Results</u>	<u>Remarks</u>
WT-45	#2 Test Frame	OK @ 497 KT	LCOS caused no failure of I/B ply. Combining glass destroyed.
WT-46	#2 Test Frame	Failed @ 708 KT	Same panel as WT-45. Compare with WT-41 impact in forward beam corner. Fracture as shown.
WT-50	Module with Interim Fitting	Failed @ 529 KT	Comparison with FM-2 shows effect of arch reinforcement.
